1.0. Streamlined Forensic Report: SFR01 ForensicCase954**2.0. Case Details**

Relates To:	XXX Police	Forensic Service Provider	Data Clinic Ltd.
Property Reference Number:		Crime/Incident Reference	XXX
Property Received Date:	03/01/2025	Socrates Number:	XXX
Case Reference:	ForensicCaseXXX	Report Number:	SFR1 [Version 1.0]
Exhibit Reference:	XXX	Client Lab Reference:	N/A
Exhibit Tag Reference:	XXX	Principal Engineer:	Chris Parry

Make: Apple
Model: iPhone 11
IMEI:

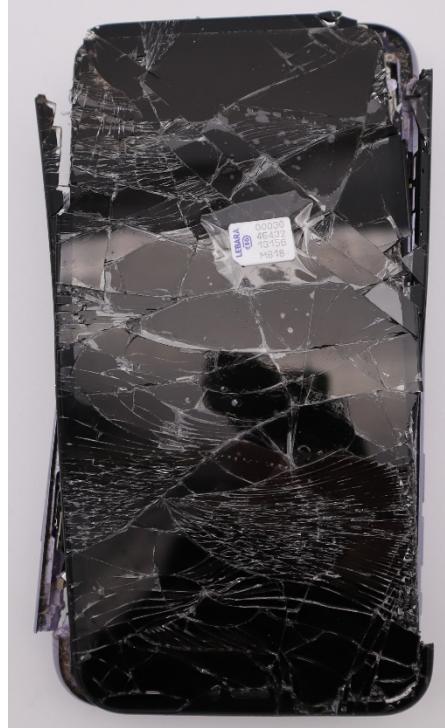
Picture Ref 6.1.1: IMG_5681.JPG

Exhibit was badly damaged and bent. Logic board removed and it was also bent (Picture Ref 6.1.1 – 6.1.6)

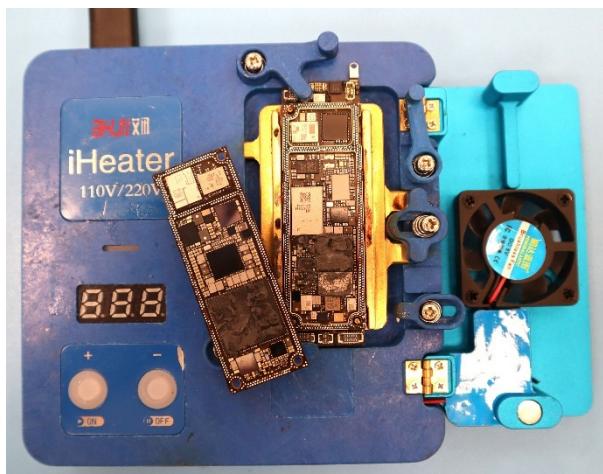
The exhibit logic board AP and RF boards were separated. This was completed using an iHeater, iPhone 11 module and appropriate heat setting (Picture Ref 6.2.1). This allowed access to the CPU and identified the damaged interposer with ripped/disconnected connections (Picture Ref 6.2.2 & 6.2.3). These damaged pads would have certainly caused instability, overheating or a 3-minute reboot issue.

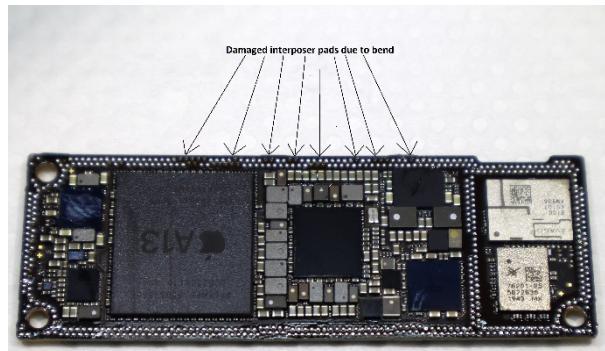
Picture Ref 6.2.2: IMG_5846_Edited.JPG

Initial inspection did not identify any main power rail shorts but did identify several disconnections between the upper AP (application protocol) and lower RF (radio frequency) logic board. Whilst they may not have prevented the device from booting it would have resulted in the phone rebooting every 3 minutes preventing any data acquisition.

A decision was taken to attempt a full CPU/NAND and logic EEPROM swap.

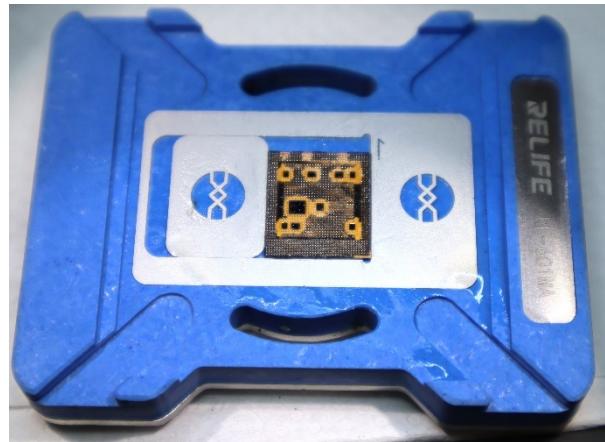
Picture Ref 6.2.9: IMG_5855.JPG

The exhibit CPU was then carefully removed from the damaged logic board using heat (Picture Ref 6.2.9 & 6.2.10). The CPU looked in good condition with no visible damage observed. The CPU has a covering of black underfill which required careful removal.

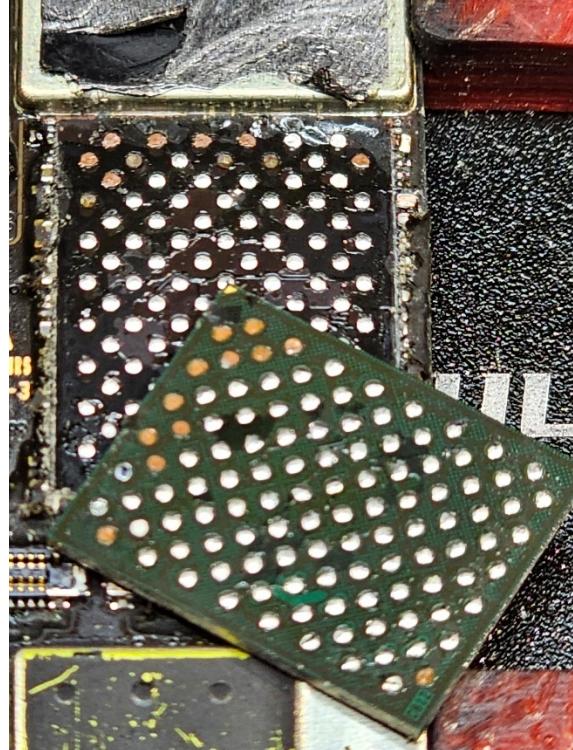
Picture Ref 6.2.11: NAND Removed.JPG

The exhibit NAND was then carefully removed from the damaged logic board using heat (Picture Ref 6.2.11 & 6.2.12). Unfortunately, unlike the CPU it was immediately clear the NAND had been partially disconnected from the logic board due to the bend in the board (Picture Ref 6.2.13) resulting in several pads being ripped from the NAND itself.

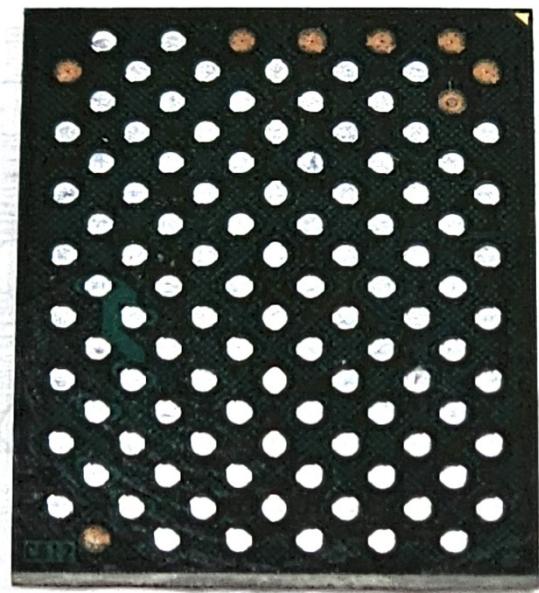
Picture Ref 6.2.13: Damaged NAND Pads.JPG

Schematics identified that out of the 8 damaged pads 7 were ground pads and not required with the remaining being a NC (no connection) pad. Thankfully, none of these 8 pads are required and therefore no repair was required to the NAND IC (Integrated circuit).

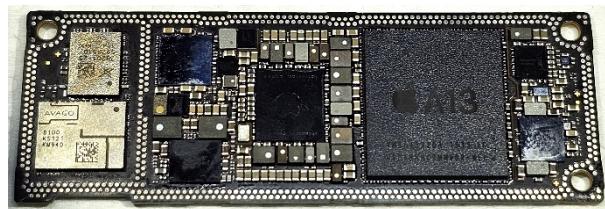
Picture Ref 6.2.18: CPU Installed.JPG

CPU, NAND and logic EEPROM installed onto receiver board and before any power provided various CPU and NAND power, data and signal lines were tested. All appeared to have the correct readings and no short-circuits were identified (Picture Ref 6.2.18 & 6.2.19).

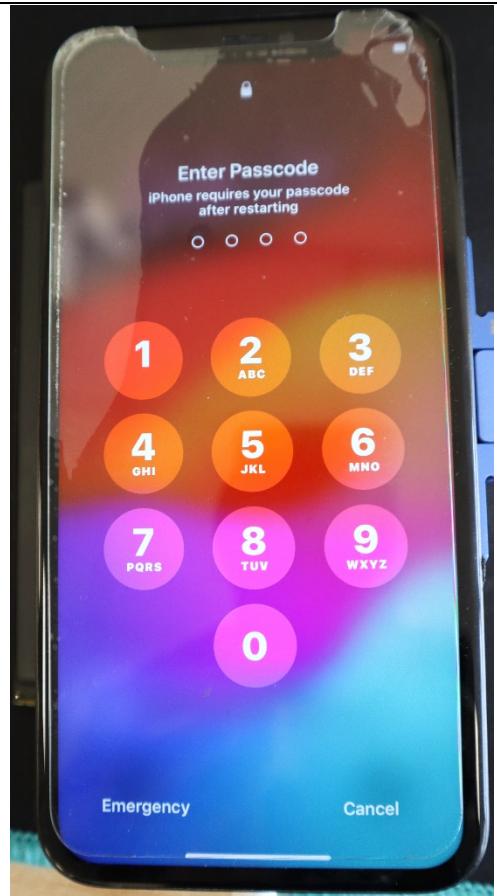
Picture Ref 6.2.20: CPU Swap Test.JPG

The AP board was then attached to donor peripheral components (screen, charging port and battery) to ensure a full boot was possible. This was completed without the RF board present, to prevent any cellular connections. The phone was prompted to boot with a USB lightning cable attached to a wall outlet to prevent any data communication. The phone booted correctly to the pin code screen identifying the CPU/NAND and EEPROM swap had been a success (Picture Ref 6.2.20)

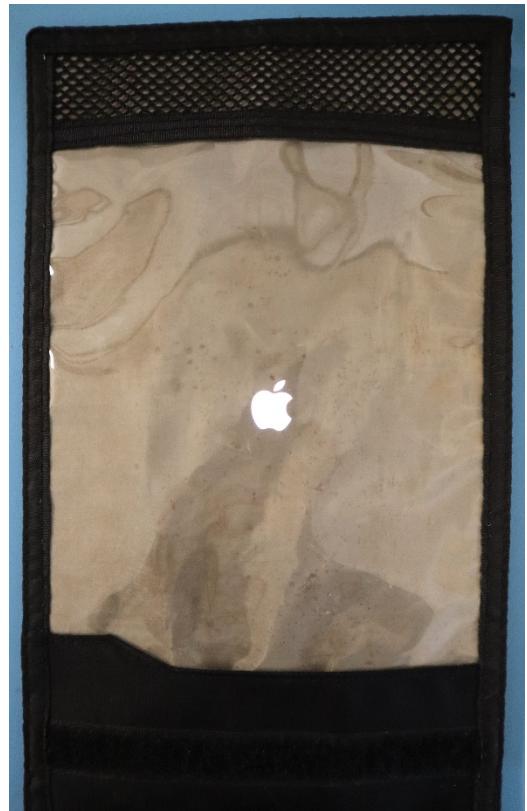
Picture Ref 6.2.26: IMG_5872.JPG

The device draws a good level of power (no short-circuit detected), shows an increasing battery percentage (Picture Ref 6.2.26) and boots to a home screen (Picture Ref 6.2.27).
