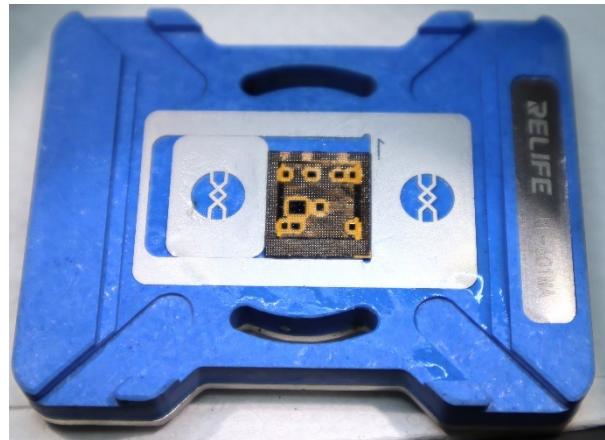
Picture Ref 6.2.9: IMG_5855.JPG

The exhibit CPU was then carefully removed from the damaged logic board using heat (Picture Ref 6.2.9 & 6.2.10). The CPU looked in good condition with no visible damage observed. The CPU has a covering of black underfill which required careful removal.
