1.0. Streamlined Forensic Report: SFR01 ForensicCase954**2.0. Case Details**

Relates To:	XXX Police	Forensic Service Provider	Data Clinic Ltd.
Property Reference Number:		Crime/Incident Reference	XXX
Property Received Date:	03/01/2025	Socrates Number:	XXX
Case Reference:	ForensicCaseXXX	Report Number:	SFR1 [Version 1.0]
Exhibit Reference:	XXX	Client Lab Reference:	N/A
Exhibit Tag Reference:	XXX	Principal Engineer:	Chris Parry

Make: Apple
Model: iPhone 11
IMEI:

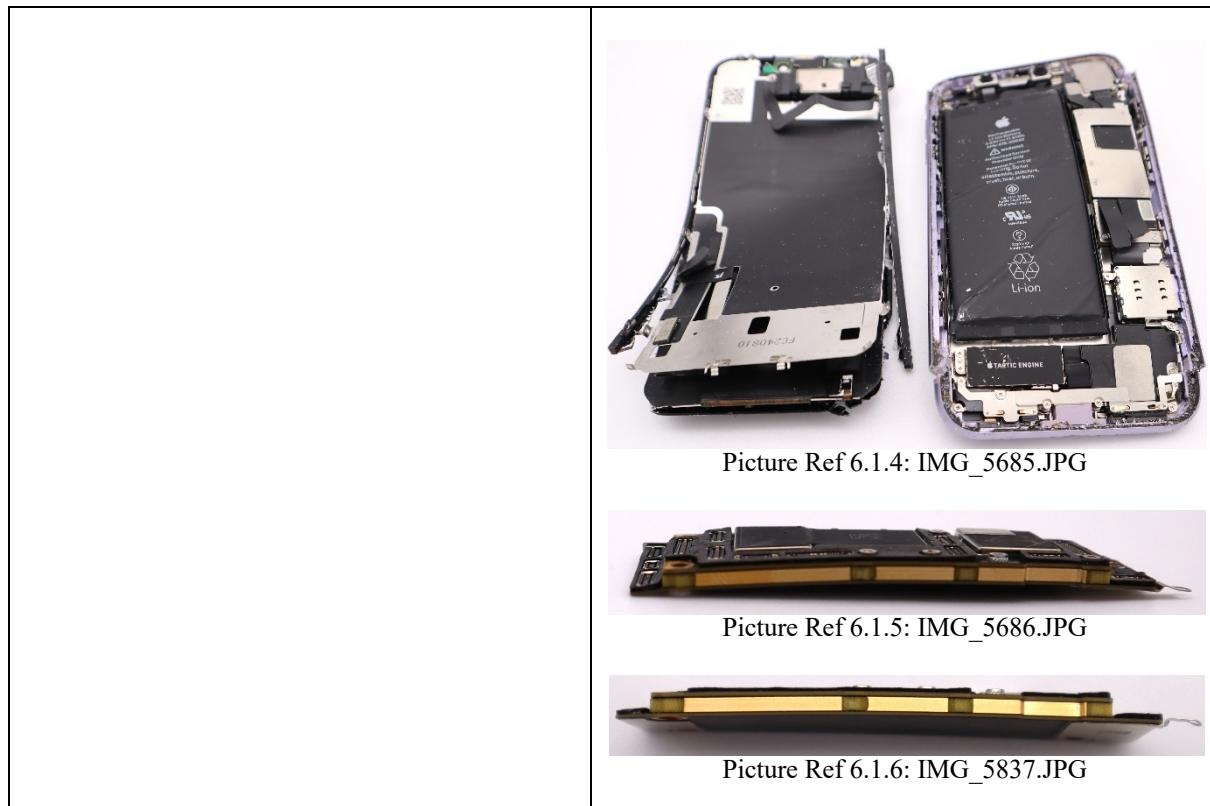
Exhibit was badly damaged and bent. Logic board removed and it was also bent (Picture Ref 6.1.1 – 6.1.6)

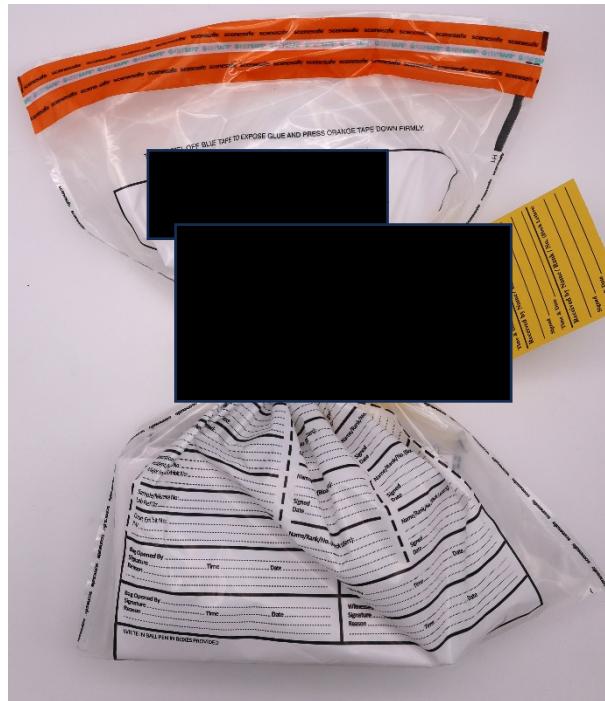
Picture Ref 8.1.1: IMG_5882.JPG

Exhibit Reference: XXX - Original peripheral components including LCD, chassis, battery, logic boards (AP&RF), screws, cameras and SIM card
